## NAIL DISTRIBUTIONS AS STRUCTURAL INSIGHT AT THE BEAVER CREEK TRAIL CROSSING SITE (25SW49), SEWARD COUNTY, NEBRASKA

A THESIS

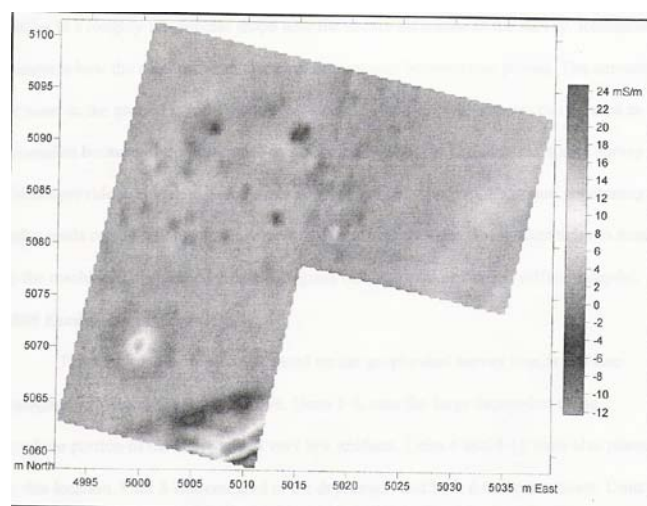
**Figure 4.** Conductivity survey image of the depression (SW) and the rectangular mound (NW). From Johnson (2006).

Surveying the site using Magnetic Gradient Survey, Conductivity Survey, Resistivity survey, and Ground Penetrating Radar (Johnson 2006), researchers were able to locate a number of anomalies on the east side of the creek near a visible depression and rectangular mound. These surface features and remote sensing anomalies were located just north northwest of the trail ruts marking the road through BC (Figure 4, 5, and 6).

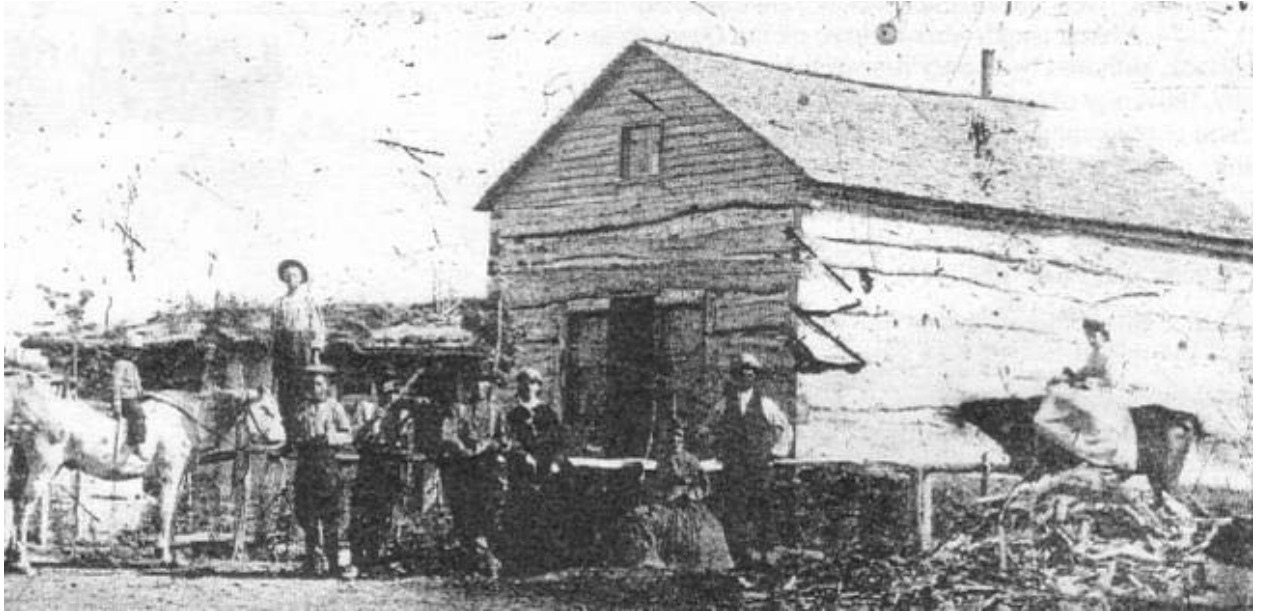
**Figure 7.** Cropped photograph of the Reed Ranch House at Beaver Crossing (1866)  
(Courtesy of Nebraska State Historical Society RG2469-05)

Figures 7 and 8, placed below, show the Roland Reed ranch as it was in 1866. Figure 9 is the excavation map of the site with an outline of the log house. Material expectations based on these images are discussed in this chapter. Since this study focuses on structural implications of the nails at the site, only the structural elements of the house that are present in the photograph are discussed.

According to Demers (in press), the log house has been classified as a front-gabled, pre-classical box style (see McAlester and McAlester 1987). The house, as shown in the photographs, is a one and a half-story building with what may be a framed attic or sleeping loft. According to evidence taken from the archaeological excavations, the house measures an estimated 36x24 feet. This was a standard size for the time period (Demers in press). Also apparent in the photograph is siding along the front gable of the upper half-story, a shingled roof, two heavily framed windows on either side of the front door that are especially visible in Figure 10, and a thinly framed front door. Coming off at an angle from the house is an ell, or a structural wing supported up upright wooden poles, boards, and covered by a sod roof. No evidence of this ell was found in the excavation of the site. The rest of the house is apparently constructed of roughly cut, irregular, squared off logs with daub.

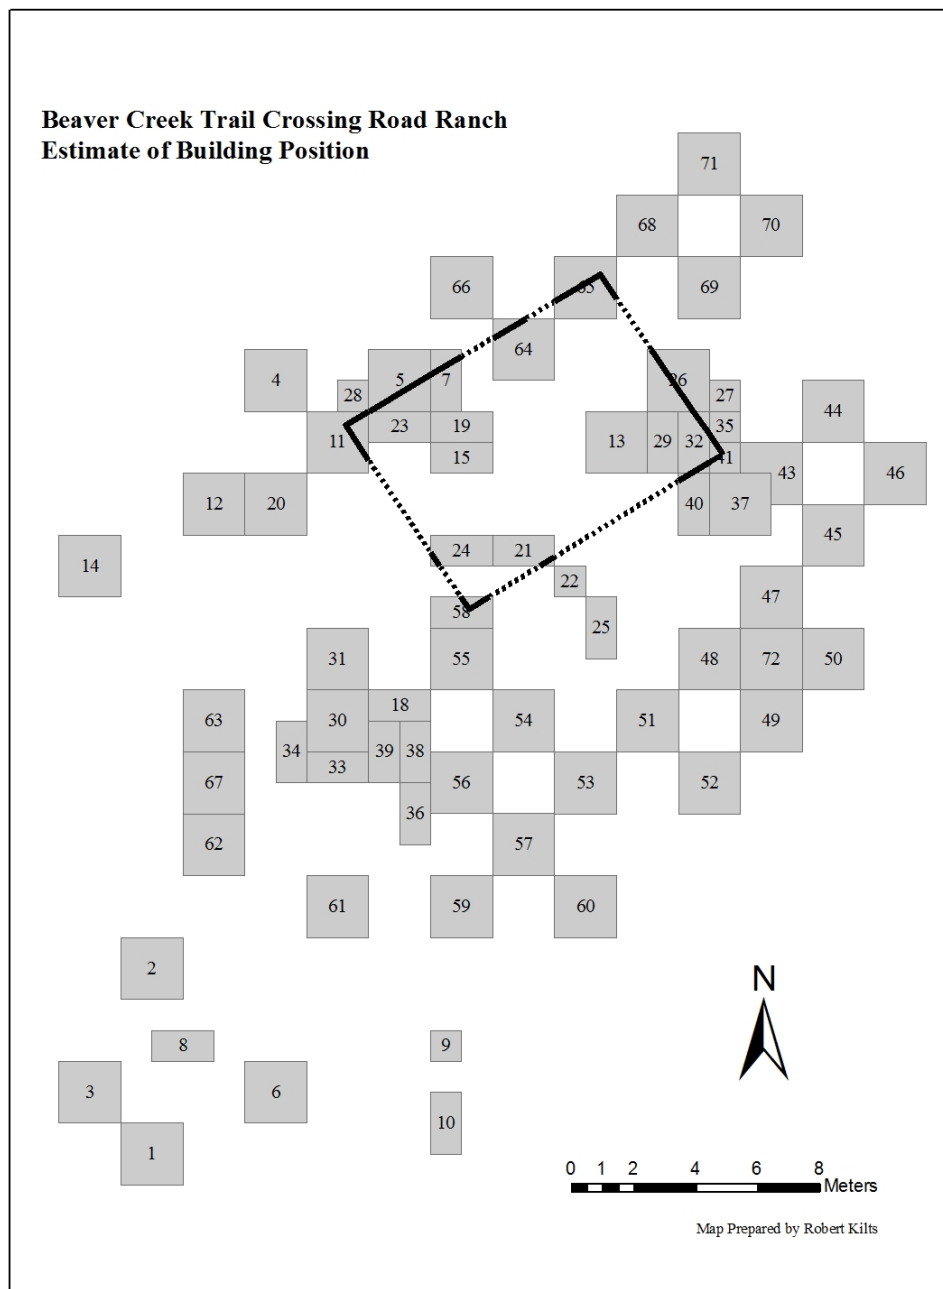
**Figure 9.** Site map showing placement of units and the estimated location of log house (Demers in press).

Overall, in 2005 and 2006, the site was heavily excavated and a significant amount of ground was covered in order to uncover evidence of the Roland Reed Ranch (see Figure 9). Large numbers of artifacts including nails, historic ceramics, faunal remains, pane glass, container glass, daub, beads, ballistics, buttons, and even some prehistoric ceramics and lithics were recovered during excavation (Demers in press). In addition, a number of

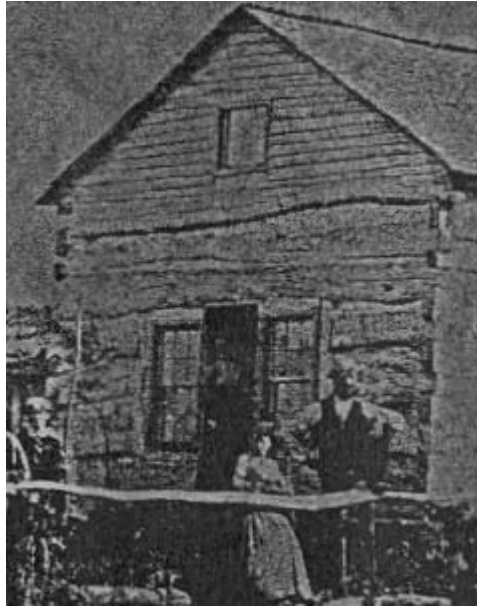
**Figure 10.** Close view of house façade from photograph in Figure 8.

The windows on the house and their associated frames, as mentioned above, would also provide a small source of nails. The door frame could also be considered in this discussion. In Figure 10, the windows on the first story on either side of the door have thick framing boards, especially on the top and bottom portions of the window frame. The door itself seems relatively thin. The window on the upper half-story, since it is smaller, also appears to have thinner frames. Nail sizes associated with these door and window frames are likely to be within the range of 6d to 10d, since 12d nails and above are generally used for very heavy framing. These frames would likely leave a smaller set of nails behind, but would add to the number of nails in the 6d to 10d categories. The door frame and the frames of the windows on the lower floor would likely contribute nails toward the larger sizes (8d-10d). However, depending on how the windows were build, the small wooden frames in between the six window panes of the lower doors would also contribute nails of smaller size, possibly 2d or 3d. Spatially, it is expected that the contribution from these features of the house will be difficult to interpret. Due to

The association of 2d nails at this site with pane glass in the same areas shows that the nails left behind were probably associated with broken windows from the house. This is consistent with the photograph of the Roland Reed house because the house, as shown in Figure 10, had three multi-paned windows on its front façade and may have had more on the opposite façade. The presence and locations of the largest 2d nail concentrations corresponds roughly with the general locations of these windows. It should be noted that single 2d nails are also scattered at various locations in the site, including three of the house corners. These may have been roofing nails, which is also consistent with the 1866 photograph.

This distribution of nails is difficult to draw conclusions from because of its small size. However, the rough rectangular shape of the nail distribution and the association of 10d nail concentrations with pane glass concentrations are consistent with photographs of the house. Some of the window frames seem almost as large as the door frames (Figure 10) and would have required 10d nails to fasten them to the rest of the house.

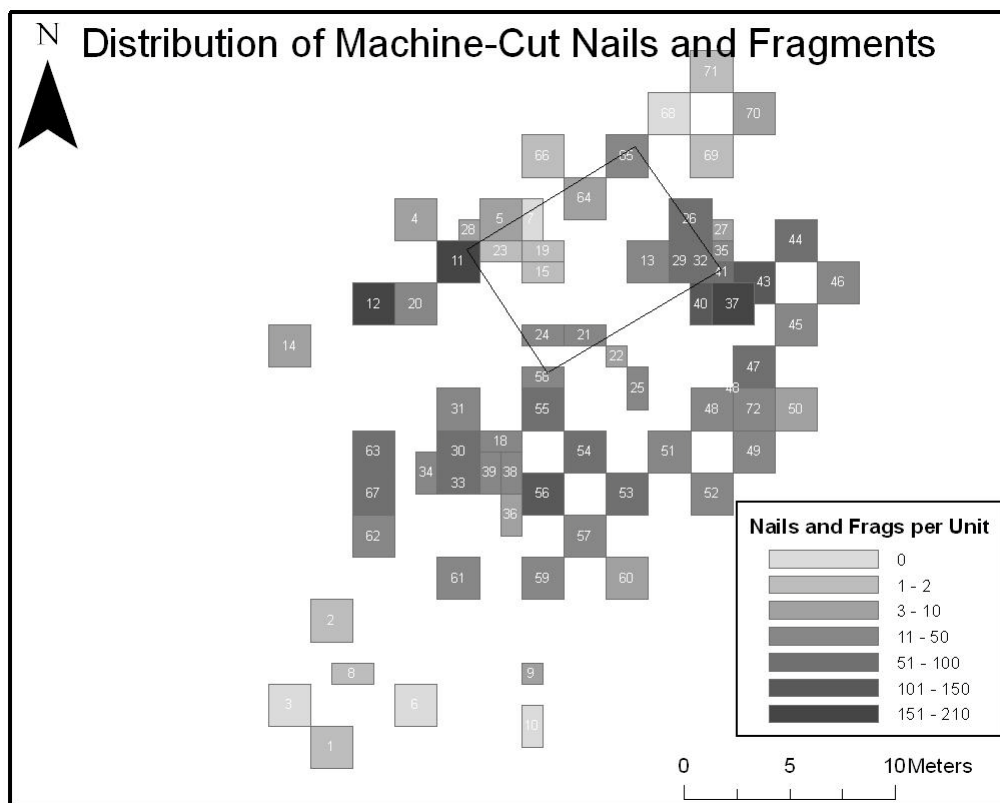
**Figure 11.** The distribution of all machine-cut nails and fragments located at the site.

Figure 11 shows the distribution of the total nails and nail fragments across the site. It presents a number of high nail and nail fragment concentrations across the site. In fact, the nails seem to be ubiquitous throughout the site with the exception of units 3, 6, 7, 10

The general, rectangular shape to the concentrations of nails in this figure, along with the abundance of seeming activity areas, belies the general shape of rectangular structure and shows evidence of dismantling activities around the house. This is consistent with the photographs of the rectangular Roland Reed log house and the history of salvage at the site.

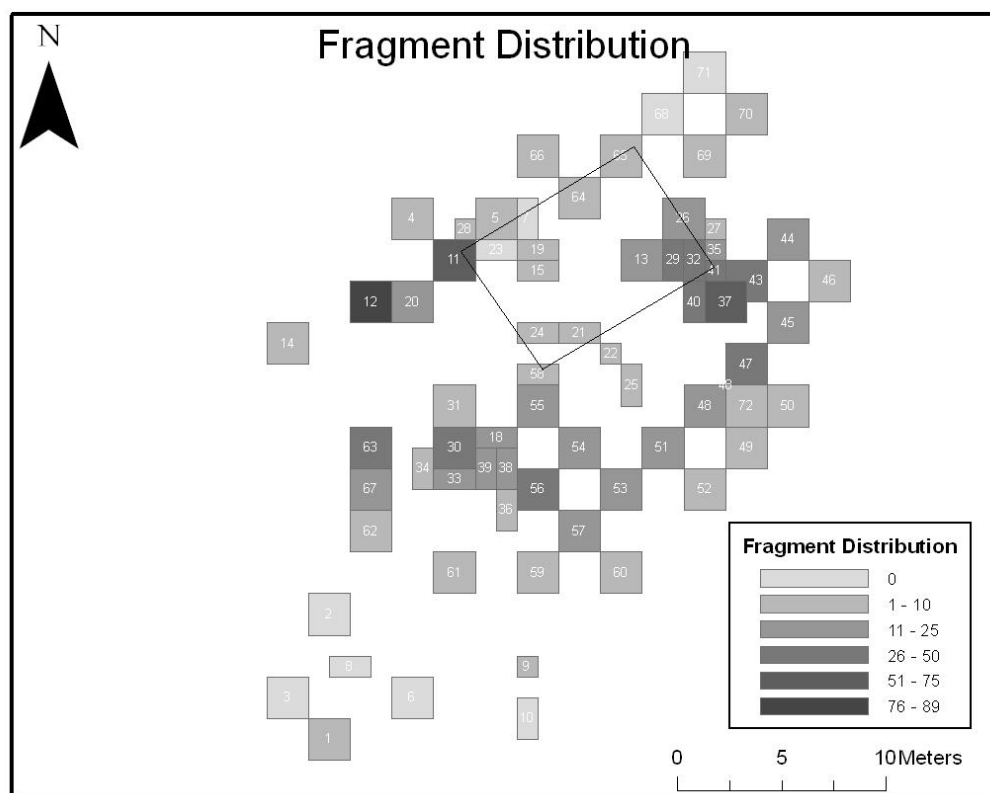
**Figure 12.** The distribution of nail fragments across the site.

Upon examination of the distribution of nail fragments (Figure 12) across the site, it is apparent that they heavily affect the distribution above showing both fragments and machine-cut nails (Figure 11). For example, many of the main concentrations are similar to Figure 11, with the greatest being located at the four corners of the proposed house site, at unit 12, unit 56, and along the southeast façade of the proposed location of the structure. The only exception is the slightly greater number of units without nail fragments, including units 2, 3, 6, 7, 10, 23, 68, and 71. The fragments are still nearly ubiquitous to the entire excavation area.

The distribution above is so similar to Figure 11 that the fragments, which make up 61.7 % of the entire machine-cut nail assemblage at BC, help to shape the overall pattern of nails at the site. These fragments are in locations that follow the general outline of the proposed structure, making a roughly rectangular shape with their greatest concentrations. In addition, they are indicative of activity areas where broken and useless wood and nails would have been left to deteriorate while better materials were removed. As mentioned in the expectations, breakage can occur as old wood is left to rot, and the nails left to rust in-situ. Discarded siding and shingles may have provided some of these fragments as these smaller pieces of structural material break or are unusable after removal. However, in this case, due to the broad distribution of fragments, these nail parts were likely discarded after being broken during the dismantling of the log house or fell from wood that was being piled areas indicated by the greatest concentrations of fragments.

Like the distributions of nails and fragments at BC, the distribution shown in Figure 12 is roughly consistent with the photograph of the site in that they mimic a rectangular structure similar to the Roland Reed log house. In addition, the presence of so many fragments is consistent with the history of salvage at the site, as are the distributions

indicating areas in which large numbers of fragments are concentrated. These concentrations, like those in Figure 11, probably indicate areas in which structural material in the process of being salvaged were piled. Good material, before removal, may also have been mingled with waste material (unusable wood and nail fragments) at these activity areas.

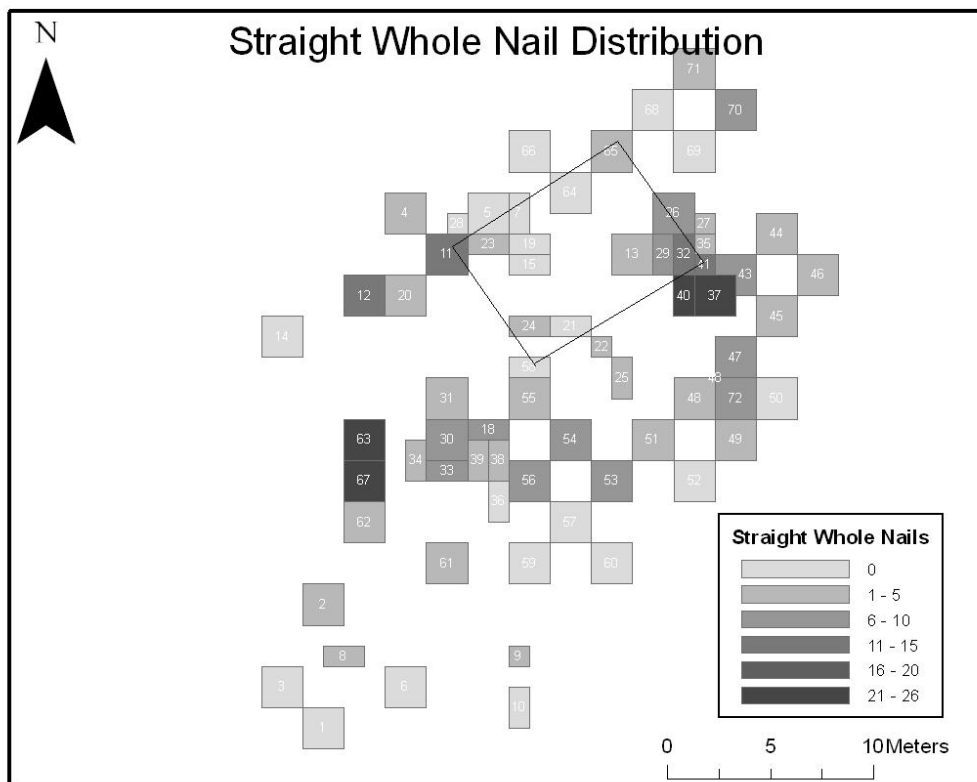
**Figure 13.** The distribution of straight whole nails across the site.

Figure 13 shows the concentrations of straight whole nails across the site. The highest concentrations of nails are located at Units 63 and 67 and at the southeast corner of the house location. Other, smaller distributions of straight nails can be seen at unit 12, unit 11, around unit 56, and around unit 72. There is also a consistent concentration of nails

Overall, the distribution of straight nails also seems to be consistent with photographs of the Roland Reed house. There is a significant amount of wood material shown in the photo that if removed, discarded, and left behind to rot, would have yielded straight whole nails. The overall rectangular pattern of nail concentrations that surrounds the house site also is consistent with the photos. Finally, the number of distinct, high concentrations is consistent with areas where wood and materials may have discarded, piled, or both are consistent with other evidence of salvage at the site.

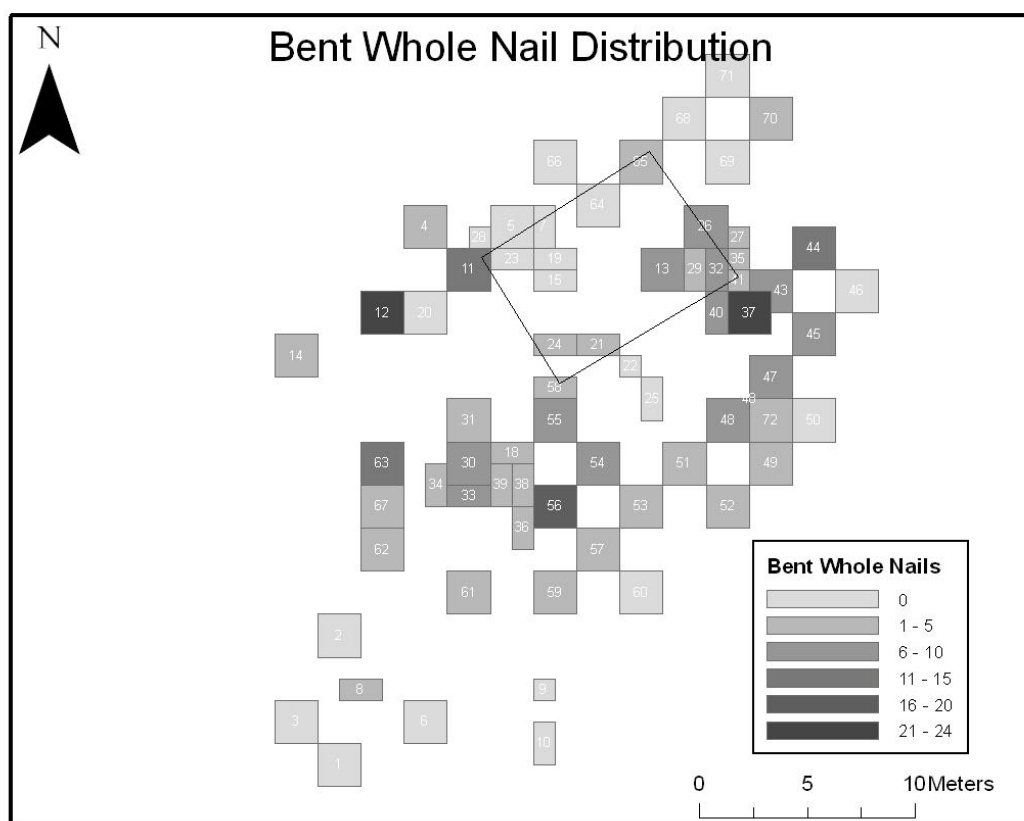
**Figure 14.** Distribution of bent whole nails at the site.

The greatest concentrations of bent whole nails at the site are located at and around the southeast corner of the proposed house location, around unit 56, at unit 63, unit 11, and unit 12 (Figure 14). There are also smaller, pronounced concentrations around these areas and, again, in a roughly rectangular shape around the southeast façade of the house location. In addition, bent nails are also widespread across the site.

Like most of the distributions, the large, rectangular swath of bent nails that reflects the proposed shape of the log house is also present. Bent nails, like nail fragments and some straight nails, would have been thrown out from under foot during building and dismantling of the house, resulting in the “halo” of bent, straight, and fragmentary nails that we have seen so far.

The bent whole nail pattern is also consistent with photos of the Roland Reed house. Again, it follows a roughly rectangular shape, the nails are widely-distributed across the site, and they seem to be concentrated in the same locations as the nail fragments. This meets the expectations outlined above and provides evidence that there was a large rectangular structure at the excavation site. It is also consistent with the other evidence of salvage found at the site.

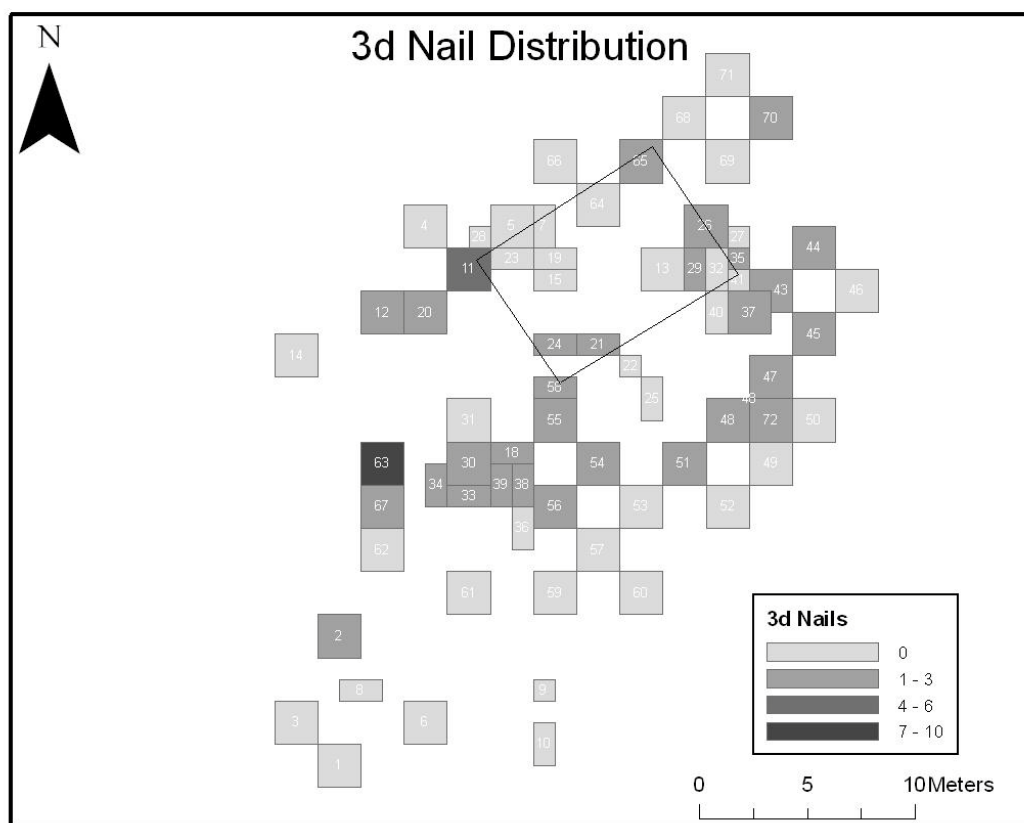
**Figure 16.** The distribution of 3d nails across the site.

The 3d nails, shown in Figure 16, are scattered more widely and in greater abundance than the 2d nails at the site. The greatest concentrations of are located at unit 63, where the most nails are found, followed by unit 11 at the northwest corner of the house. The rest of the nails are evenly distributed in a clear rectangular pattern around the southeastern façade of the house location.

In both the material expectations and in Table 2, 3d nails might have been used with wall and ceiling lath, shingling, and minor window-pane frames. The large concentration of nails at unit 63 corresponds with both the large amount of pane glass located there and the overall concentration of nails in general and straight nails at that location (see Figures 11 and 13). This means they could have either a shingling wood or window-frame

context. Concentrations of 3d nails at unit 11 and in the rectangular pattern around the southeast side of the house are likely associated with shingles as they are more abundant than is warranted by a few windows and that they are suitable for shingling and siding work. These were likely discarded with shingles and siding as those were removed and cast aside. Nails that were pulled clear out of the wood were likely to have been thrown a distance away in order to keep them out from underfoot for safety reasons.

Looking at the patterns in Figure 16, it is likely that 3d nails at this site were being used for roofing and siding more than they were for the lighter window framing. This is also consistent with the shingled roof and sided upper story of the house in photographs of the Roland Reed Rancho.

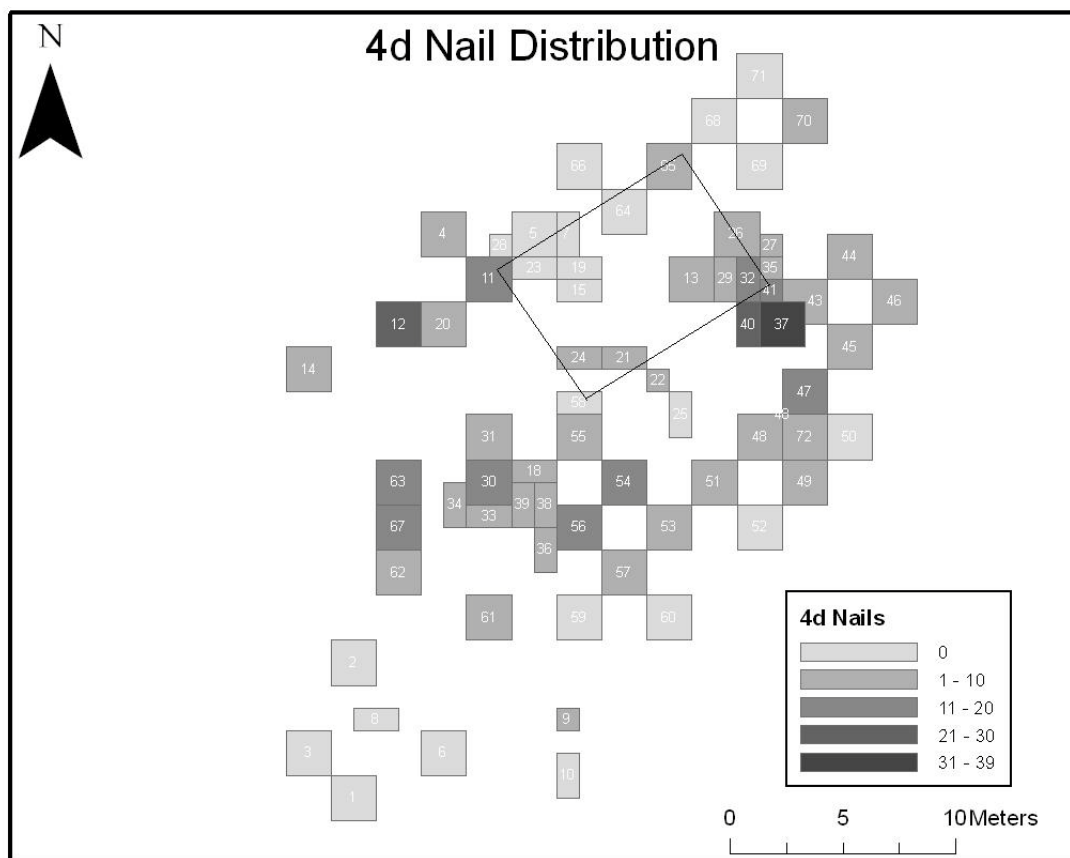
**Figure 17.** The distribution of 4d nails across the site.

The presence and distribution of so many 4d nails is consistent with photographs of the house from 1866. The photographs show siding and shingles on the upper story of the house that would have been removed in order to get at the more useful wood that made the frame of the upper story. In addition, these features would have been replaced occasionally during the life of the house as shingles and siding wore out. It is not surprising, then, to see so many nails of the 4d category and at locations where materials were being discarded or piled up. This makes the distributions consistent with evidence of salvage at the site as well. It should also be noted that the discard areas in this distribution also correspond to those found in the previous distributions. The activity areas located at units 63 and 67, around unit 56, at the southeast corner of the house location, and the rectangular pattern of nails surrounding the house all seem to be common themes. The 4d nails contribute greatly to the concentrations above for bent and straight whole nails and the distribution of all nails and fragments across the site ( Figures 11, 13, and 14).

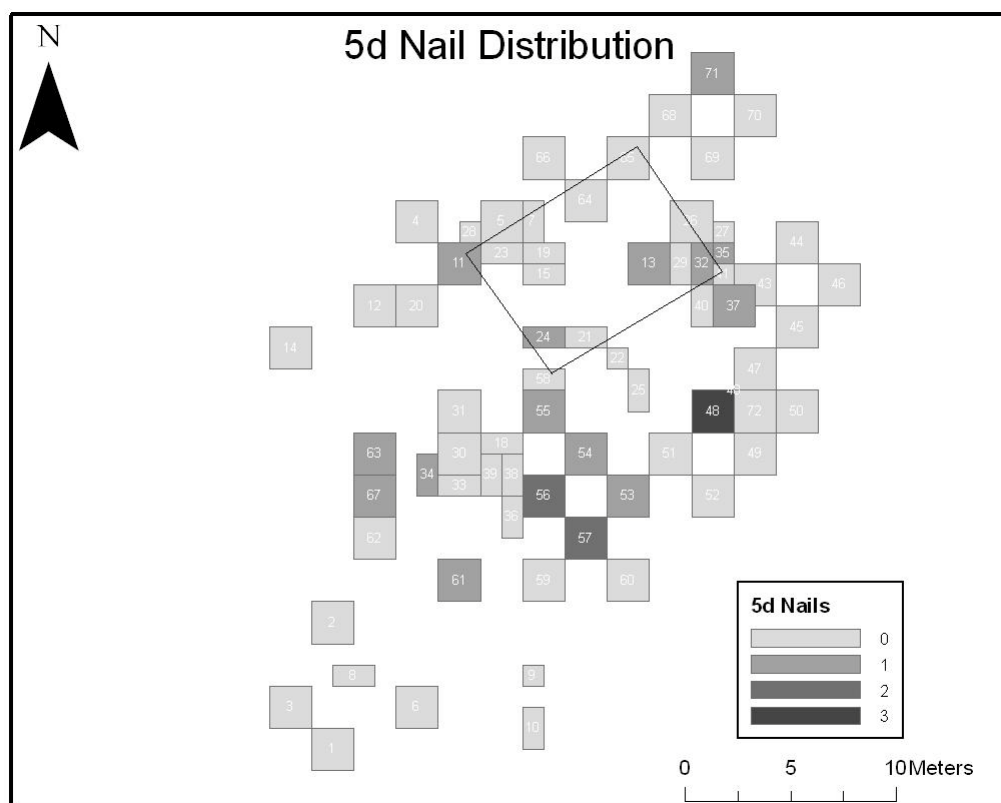
**Figure 18.** The distribution of 5d nails across the site.

The two main concentrations are near locations with high concentrations of pane glass at the site. Unit 56, for example is specifically mentioned in Johnson (2006: 113-115) as a locus with a high concentration of pane glass that may be associated with windows at the front of the house. Unit 48, upon examination of pane glass concentrations, also bears a high concentration of glass. Thus, it is likely that the 5d nails are associated with the smaller upper windows seen in photographs of the site. These windows had smaller frames than those near the front doors that could have been fastened by 5d nails. If that is the case, then they were discarded at the locations where 5d nails are present. The other, single nails scattered across the site may have been used for other purposes associated with shingling or siding. It is possible that a few were used for this purpose as well as the 4d nails.

The distribution of 5d nails seems consistent with the Roland Reed Ranche, especially in light of the existence of smaller window frames that could have been fastened with 5d nails on the upper story of the building. Their concentration near areas where pane glass is concentrated also supports this contention. Finally, the scattered state of the nails is in keeping with salvage evidence at the site.

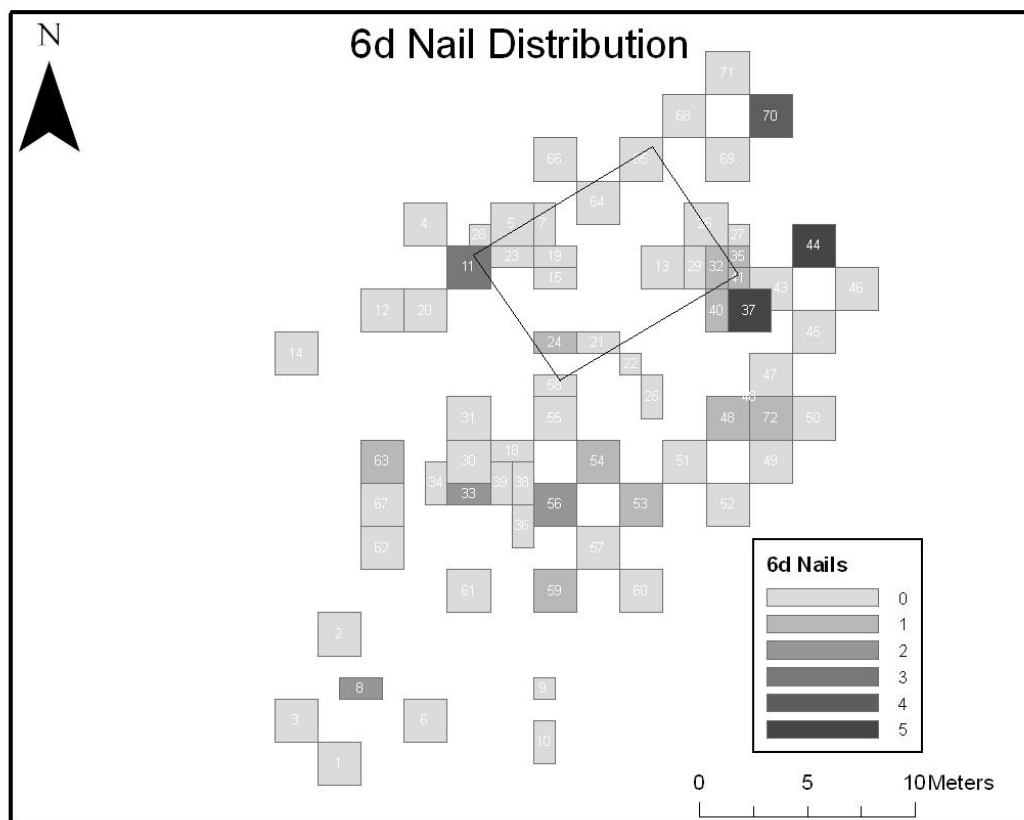
**Figure 19.** The distribution of 6d nails across the site.

The location of some of these nails at a major dumping/piling area, and in association with higher concentrations of pane glass seems consistent with the expectation that these nails were used for window framing, which is also consistent with photographs of the house. In addition, the location of the greater concentration near the east of the house, where there may have been another window, is also consistent with the photographs. The

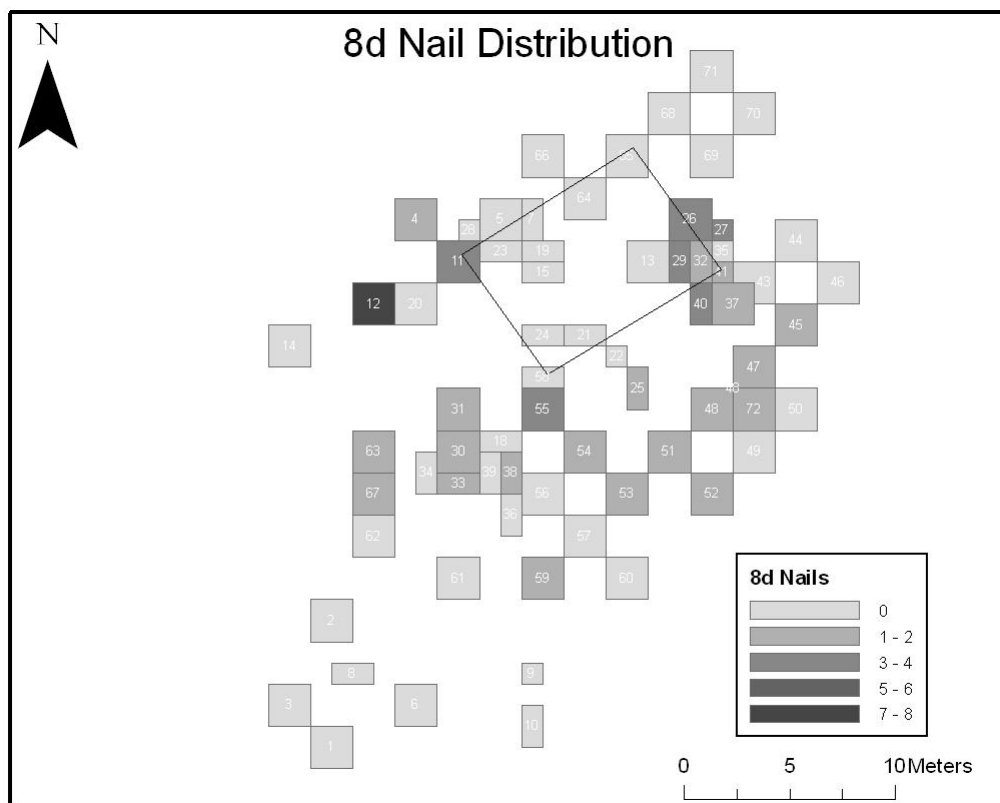
**Figure 20.** The distribution of the 8d nails across the site.

Most of these concentrations are not unexpected, such as those at unit 11, unit 55, just north of unit 56, and at the house's southeast corner. Since these nails were used for frame-boarding, the fastening of wood grounds, and flooring, it is likely that they were associated with the house's second story, being used to help support the frame of that area and floorboards that would have likely been present. It is also possible that they came from the interior of the second story, which may have sported some light framing boards and wood grounds for interior walls, and floorboards. Some of these wood materials, if still useable, would have had their nails removed and discarded in the areas where they were piled. The nails were also less prone to breaking and likely more salvageable, resulting in smaller numbers. The concentration of 8d nails at unit 12 is interesting because it is the only larger nail size present in that unit in a relatively large concentration. Nails of 5d and greater are very rare in that unit. This may indicate that smaller pieces of wood, such as grounds or broken floorboards were discarded in the trash pit as well. Finally, the rectangular concentration of nails around the house's southern side is probably the result of removed nails being cast aside to get them out from under foot during construction and dismantling activities.

These patterns above are consistent with the general shape and build of the house seen in the photographs, and it is likely that the 8d nails were associated with more than one of the purposes above. The fact that they have greater concentrations than other large-sized nails (6d – 10d) may indicate that they were associated with materials that were more likely to be discarded such as broken floorboards, wood grounds, or smaller framing boards.

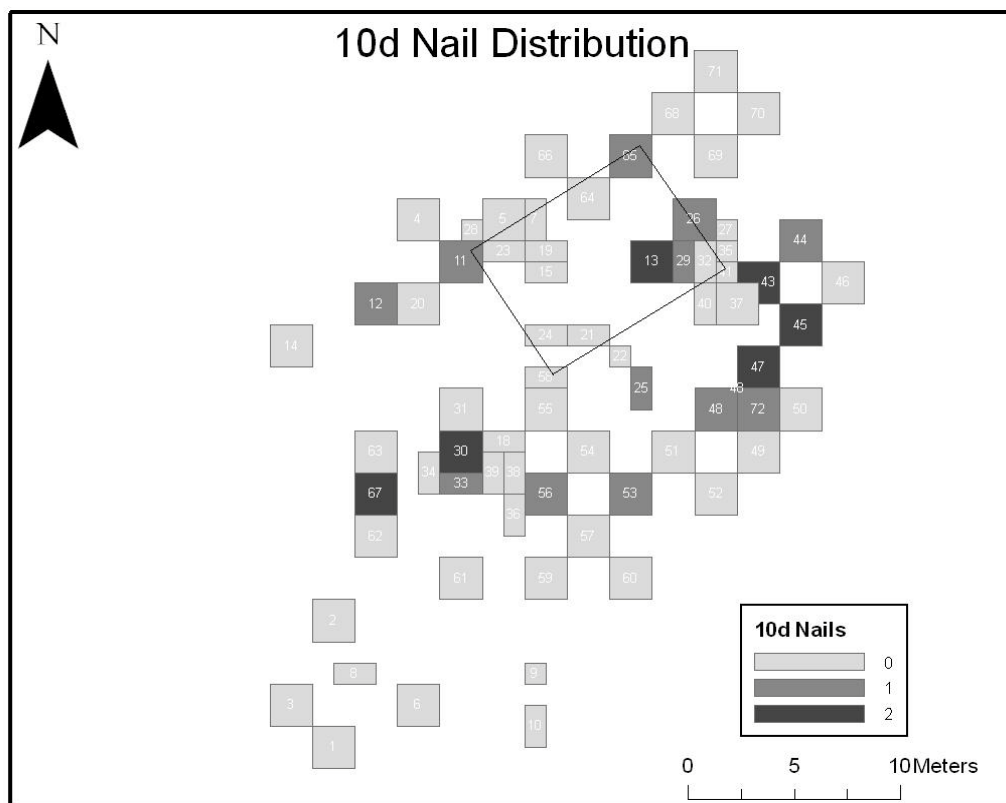
**Figure 21.** The distribution of 10d nails across the site.

It should be noted that 10d nails were used to fasten boards that were more likely to be salvaged because of their greater size and resistance to breakage. Many 10d nails may have been taken along with these boards. Further, 10d nails are large enough to warrant recovery and re-use and this may have been salvaged themselves. Those that are seen at the site are likely the result of accidental discard or discard due to bending. The loose rectangular pattern is probably a result of this discard during construction or dismantling activities at the site. The two concentrations are near units 63, 67, and 33, unit 56, and the southeast corner of the house, the area where other wood materials concurrent with smaller nail sizes were likely discarded or piled during salvaging activities. These small concentrations are also near areas with high pane glass concentrations, so it is possible that these larger concentrations are areas where door frames and window frames on the two house fronts were dismantled, leaving a few nails behind. This seems to be the case, since unit 33 has a particularly high concentration of pane glass along with the units surrounding the southeast corner of the house (Johnson 2006:113-115).
